# Manhole Inspection Summary

Manhole # S47K\_\_005MH

**Inspection** ☐ Is Incomplete Rating: **5) Immediate Attention Required**

**Location** Address: **2227 essex st**

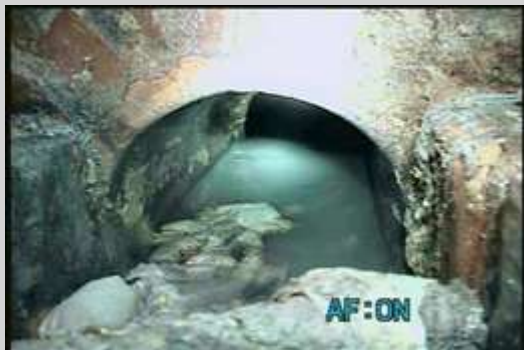
12 O'Clock Outflow

8 in. Circular Gravity Sewer  
Pipe Out @ 12 O'Clock

Pipe Material: **Clay** ☐ Pipe Lined

Invert Depth: **9.90** (ft.) Flow Characteristics: **Fast**

Deposits: ☒ None ☐ Mud ☐ Sludge ☐ Debris ☐ Grease

Infiltration: **None** Pipe Seal Cond: **Unknown**

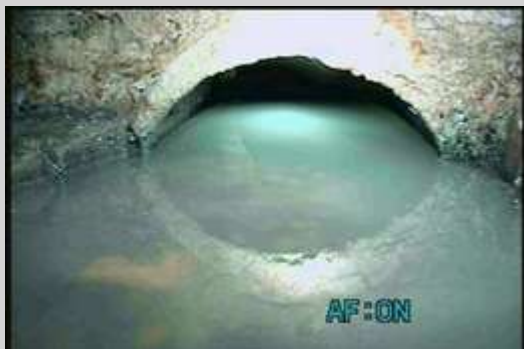
3 O'Clock Inflow

8 in. Circular Gravity Sewer  
Pipe In @ 3 O'Clock

Pipe Material: **Clay** ☐ Pipe Lined

Infiltration: **None** Pipe Seal Cond: **Unknown**
